# **The Norske Skog Waste Site Eastern Embankment: How Well It Is Functioning and What If It Fails**

By  
Alexander Mednick

June 2006

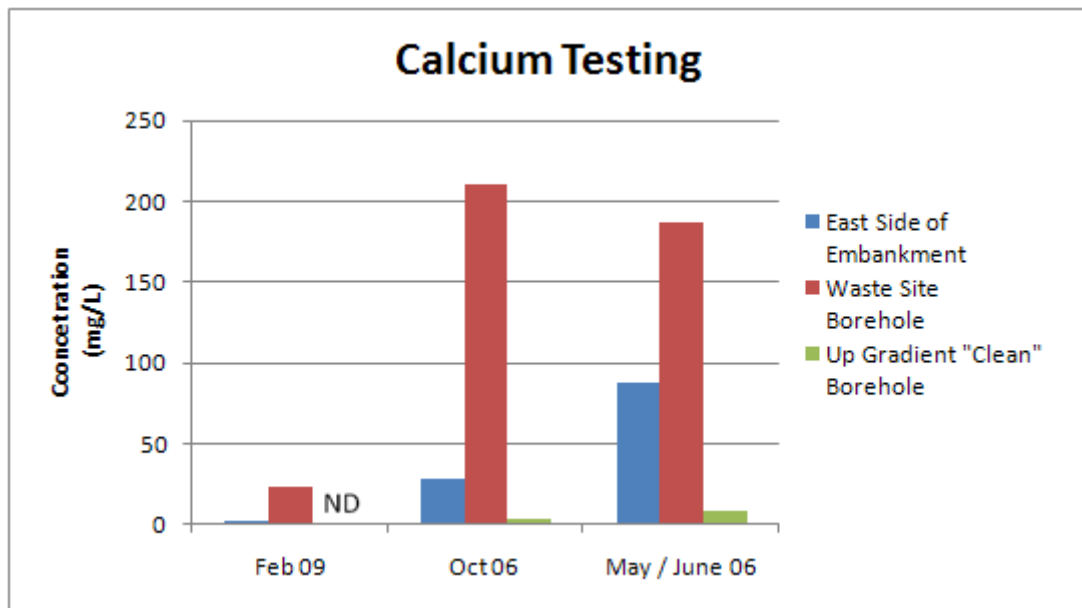
Figure C-1. Sample testing results for Calcium.

It can be seen from Figure C-1 through Figure C-4, that contamination levels for Zn, Ca, K, and Na are all higher around the Lower Embankment than they are at the SKM110, the “clean” borehole. Of these four elements, only Zn and Na have ANZECC guidelines for recreational water use. All the values for sodium fell well below the guideline of 300 mg/L. For zinc, the guideline of 0.008 mg/L was exceeded in boreholes SKM106A, SKM106B, SKM108A, SKM108B, and SKM112B in 2009 and SKM112A in 2006.
