***Testing the Solid Waste Leachate and Water Quality of the Norske Skog Pulp and Paper Mill in Kawerau, New Zealand to Investigate Industrial Contamination of the Surrounding Surface Water and Groundwater***

Alana Dingman  
Frontiers Abroad 2012  
Final Report  
13 June, 2012

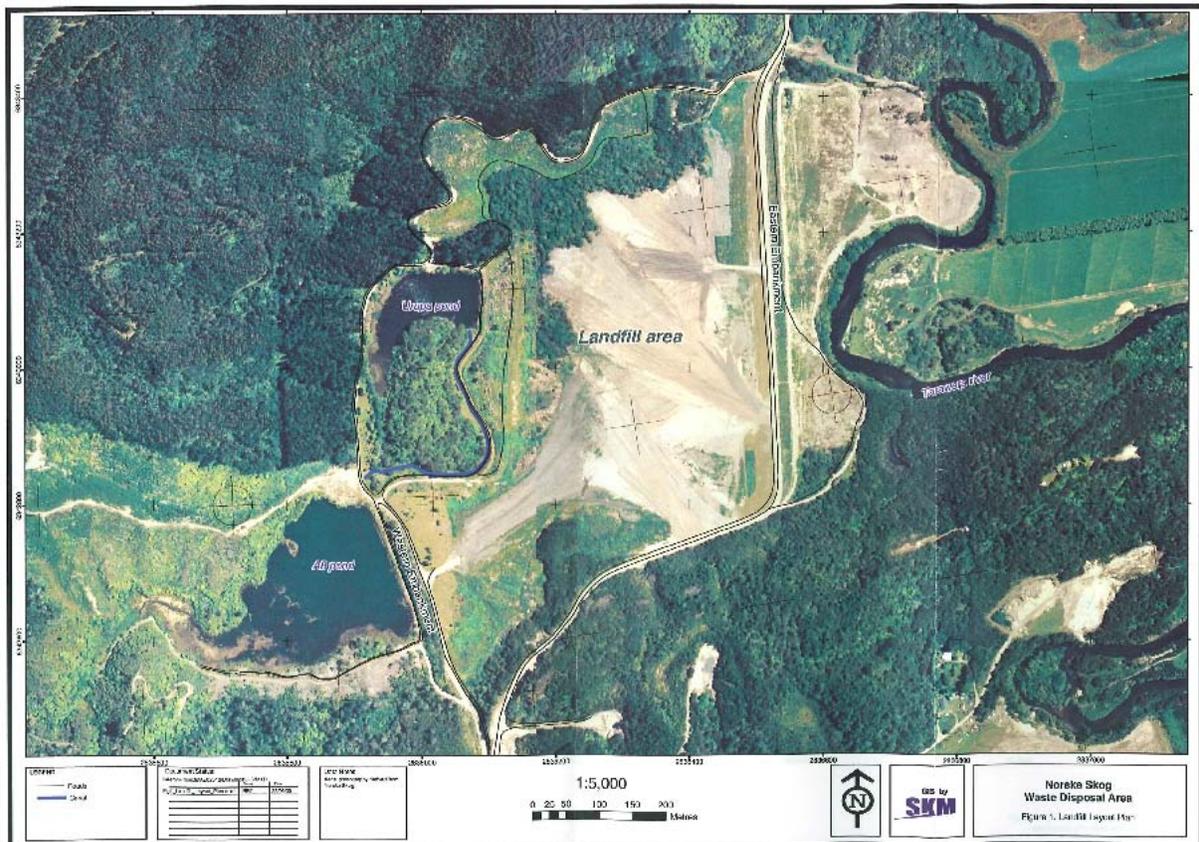
Map of Waste Dump Site and Adjacent Ponds, taken from Angela Slade

The unaffected water in this area includes a spring and the affected area includes two ponds down gradient of the spring. Today, over 20m of waste covers the lake area and geothermal features. The lake no longer exists, and the geothermal resource is rendered useless. The site is situated on permeable pumiceous rock, and the area has known faults active as recently as 1987. It is also as close as 100m to the Tarawera river and has a shallow water table. Some efforts have been made to ameliorate environmental impacts. A containment pond was constructed on site, but has failed three times and has allowed for groundwater and soil contamination, proving it ineffective. The current proposed solution is to cap the waste site with semi-permeable material, and to top that with native flora (Hikuroa and Slade 2011).

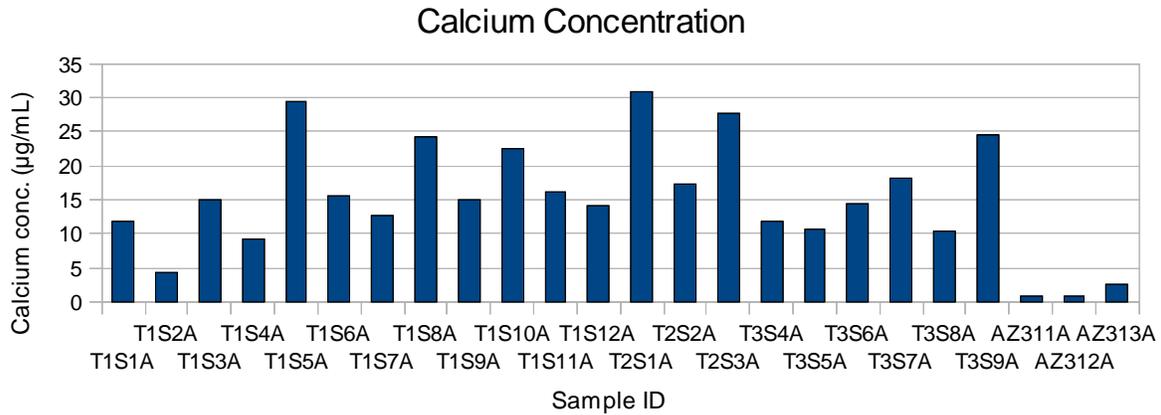
The experiment conducted measured the cation and anion concentrations in 21 solid waste samples, labeled by transect number (Tn), sample number (Sn) and by set (A or B). The Water samples are labeled according to location, as AZ311, AZ312, and AZ313, and by set as well (A or B). The table below shows the cation concentrations of Calcium, Magnesium, and Sodium in  $\mu\text{g/mL}$ :

Above, Calcium concentrations do not appear to show a trend by transect. There are also no extreme outliers. It is worth noting that the concentrations are significantly lower in the water samples. This may be due to the way Calcium behaves in water, and more readily dissolves and becomes diluted in water than in solid matter.

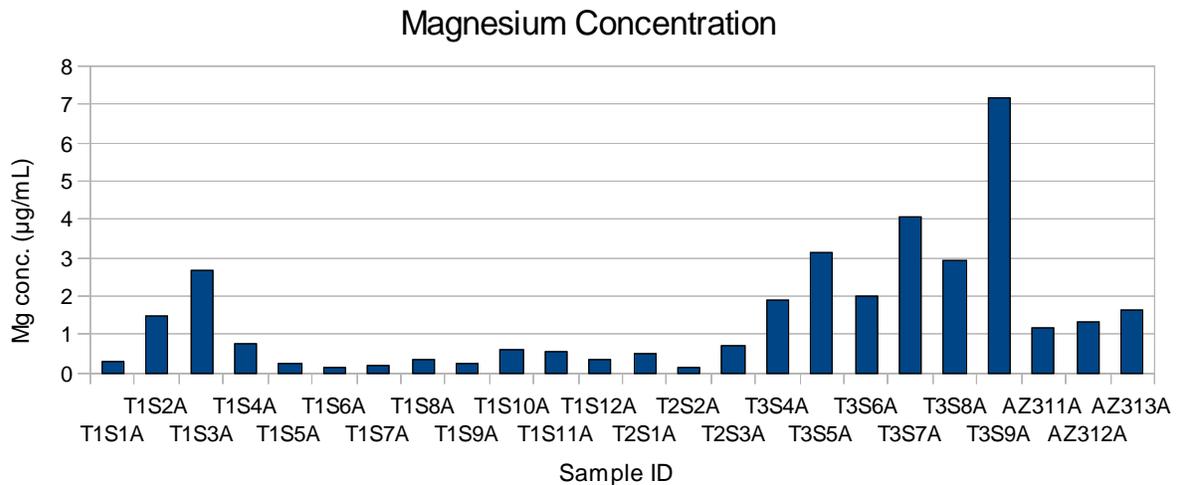
In the graph of Magnesium concentrations, there are no strong trends among transects one and two. However there is a spike in concentration at the beginning of transect 1. This may be due to the proximity to a pond, as transect 1 started close to a pond and each sample moved further from this feature. These values in T1S2A, T1S3A and T1S4A are similar to the concentrations in the three water samples. The water samples are all at similar concentrations, which may be due to the ease with which cations travel through water systems. They also slightly increase with each sample. The values also spike at T3, most likely because it was more recently produced at is leaching at higher rates than solids that have been in the landfill for a longer period.

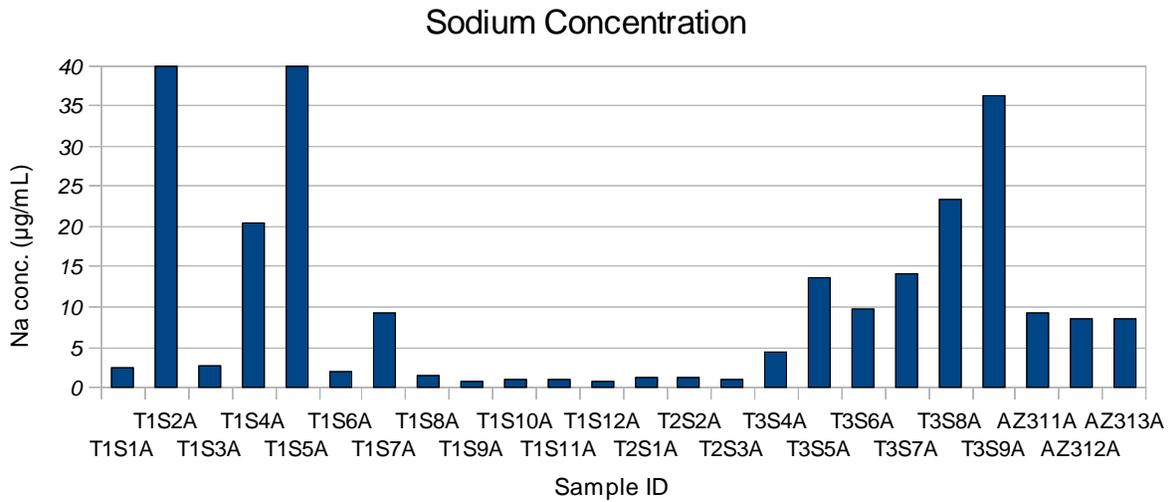
The Sodium concentrations varied the most of all the cations tested. T1S2A and T1S5A were extreme outliers and had concentrations of 363µg/mL and 501µg/mL respectively. These values were most likely subject to contamination. This graph shows a similar trend in T3 and the water to the Magnesium data, although at a higher concentration. This reinforces the idea that the temporal variation is a major factor in leaching rates.

No values of Ca or Mg were too high, but when Na cations were tested it was found that T1S2A and T1S5A were still too concentrated after initial dilution, and were then diluted by 20 times and 30 times respectively. The values in table 1 have also been adjusted for this.

A fifth reason for variance is potential human and lab error, which may have caused contamination of samples. The sodium outliers for example were yellow in color, unlike the other samples. It was determined that the discoloration was due to contamination between sample collection and sample preparation. To eliminate bias, it would have been ideal to collect samples of leachate in the field, rather than creating the leachate in the lab.

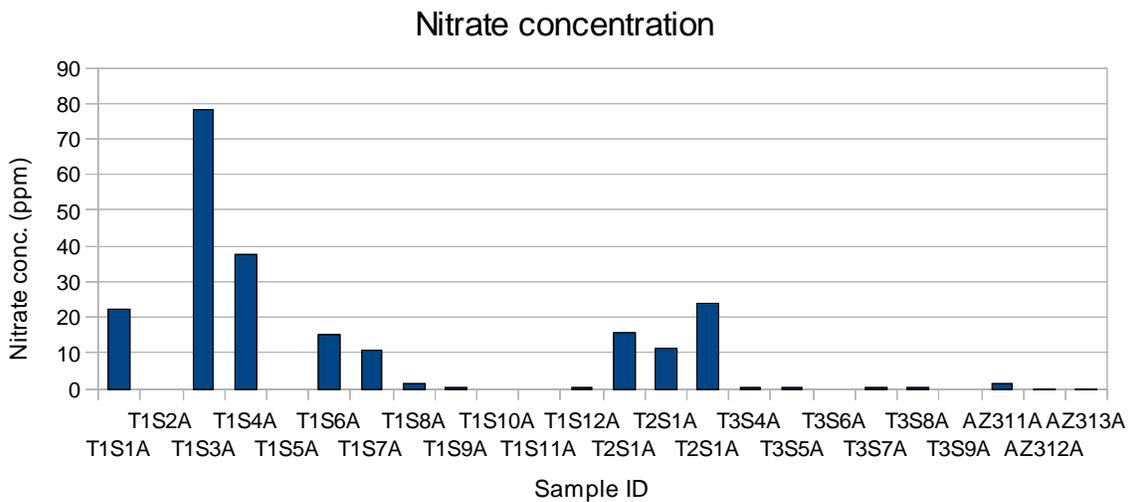
The following graphs show Nitrate, Chloride, and Sulfate concentrations of solid and

water samples in ppm:

The Nitrate data is incomplete and this anion was not detected in every sample. There is

no definite trend in this data.

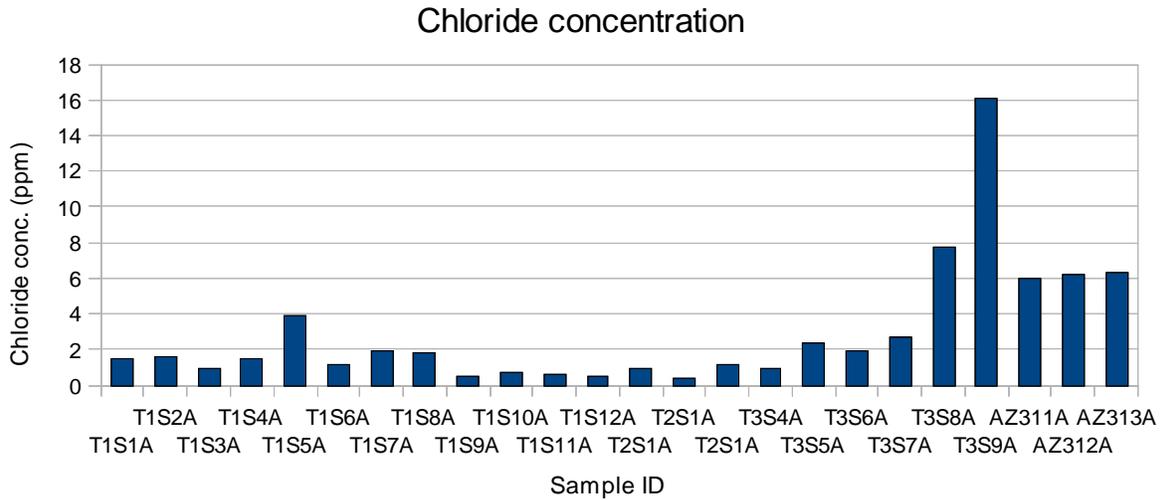
Chloride was found in every sample. This also has the same trend as Calcium and Magnesium in T3. The water samples are also consistent and are relatively similar. Otherwise, the concentrations of chloride are low in T1 and T2, the older samples.

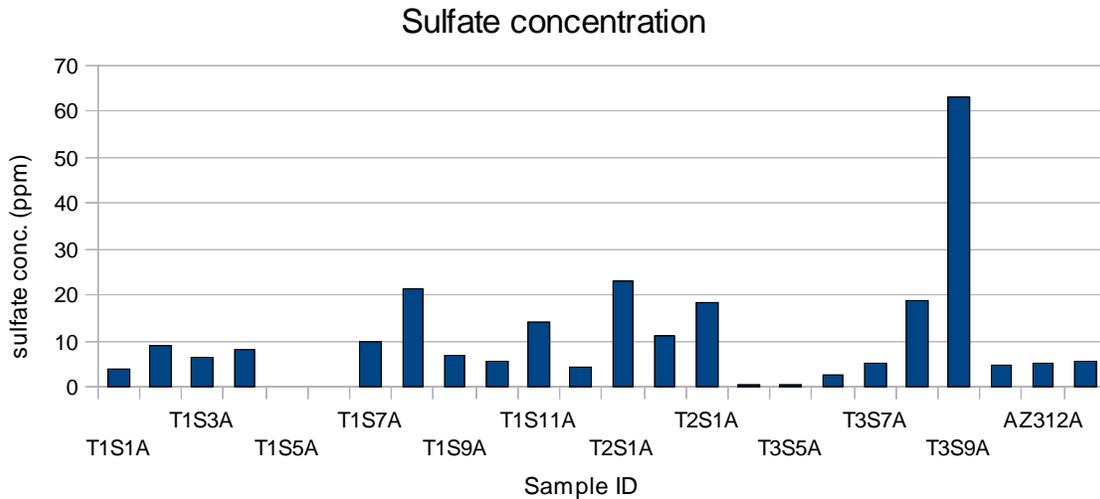
The Sulfate data set was also incomplete. This showed an unusual spike in T3S9A, similar to the other chemical tests. Transect 3 also rapidly increases in concentration spatially. The concentrations remained constant in the water samples.

Another reason for variance in leachate results may be temporal. Solid waste collected from T1 was older than solid waste from T2 and T3, which had been dumped most recently. This could explain why T3S9A showed higher concentrations of contaminants overall. This sample most likely held more contaminants than those from T1 because it was not exposed to the elements as long, and did not have time to leach as many chemicals.
