Erin Camp
Geography-333
18 June 2010

Documenting the Natural and Anthropogenic Changes to Te Awa o Te Atua During the Past 100 Years

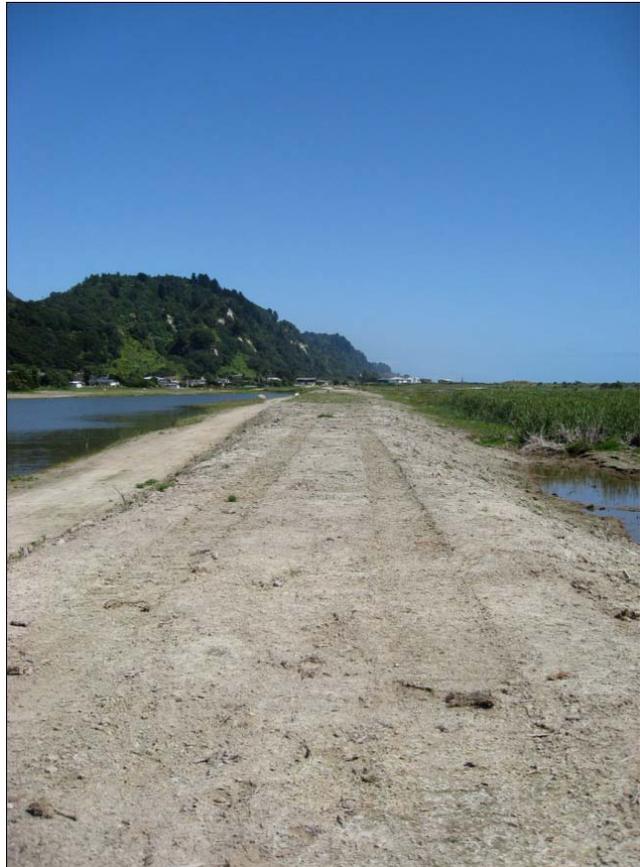
Figure 3: Embankment of lagoon, which provided an ideal GPR transect.

A total of two GPR transects were run, both of which were executed at wavelengths of 150 nanometers with a 200 MHz antenna. Markers were set up every 50 meters along the embankment; no markers were used on the detour routes. The main embankment was exactly 1050 meters long, so a total of 22 markers were used. The first straight GPR reading was performed to get a general image of the lagoon's subsurface (See Figure 3).

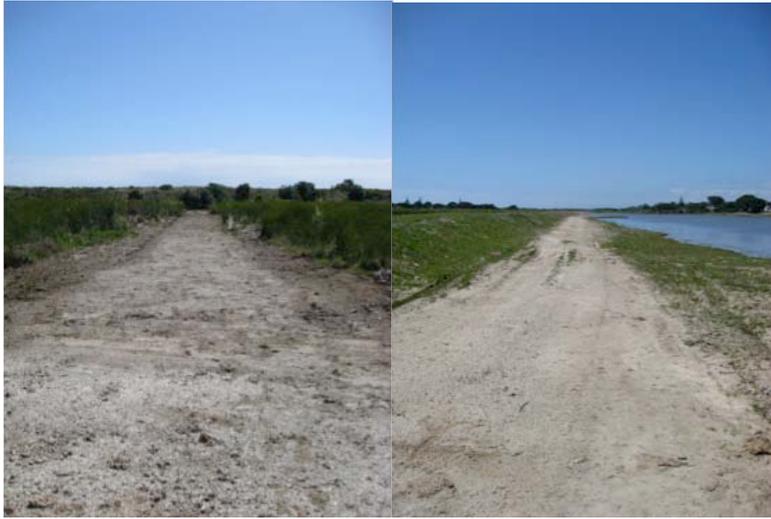
Figure 4: Perpendicular detour pictured left; parallel detour, right.

The second reading, heading the opposite direction along the same path as the previous reading, was performed in order to get readings for the water table and other interesting features that may have been near the lagoon, such as dunes. In addition to the east-west transect along the north side of the lagoon, two GPR 'detour' transects on either side of the embankment were conducted: one of which split off perpendicular to the embankment to the north and the other split off sub-parallel to the embankment to the south (See Figure 4). Both of these 'detour' transects were at lower elevations than the original embankment, nearer to the water level of the lagoon.

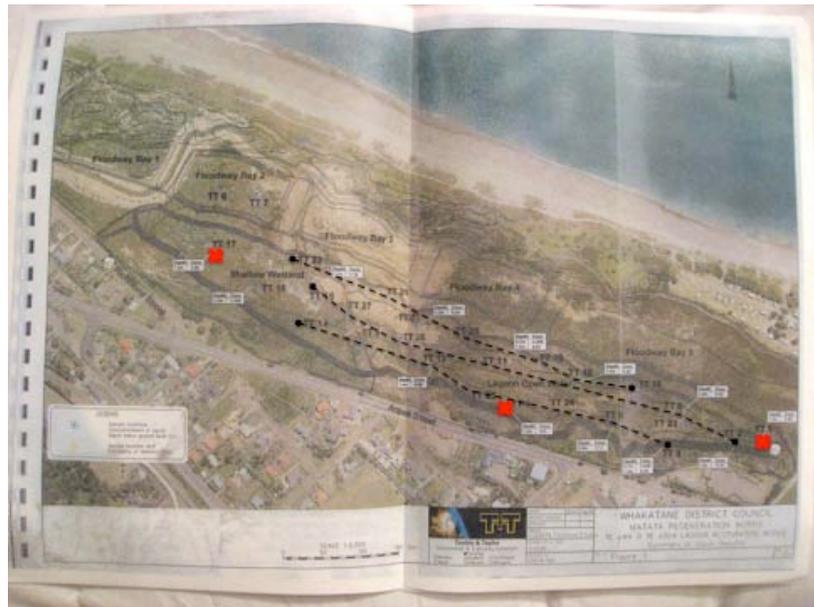
Figure 6: Modified lagoon map showing the three fence diagram transects. Original map from Tonkin and Taylor.

excluded from the fence diagrams and all further data interpretation, and were marked with a red 'X' on the transect map (See Figure 6).

Using the Tonkin & Taylor borelog map, three transects were laid out across the lagoon in the west-east direction: one of the northern bank, one through the center, and the last of the lagoon's southern bank (Refer to Figure 6). Each transect was then utilized for the creation of three fence diagrams to approximate average

thicknesses of the debris flood layer. The northern bank transect included six borelogs: TT15, TT27, TT26, TT11, TT8, and TT2. The central transect included six borelogs: TT22, TT21, TT20, TT19, TT10, and TT18. Lastly, the southern transect included five borelog: TT14, TT12, TT25, TT9, and TT3. Although the borelogs did not all lay perfectly on the transects, it was assumed that the margin of error was negligible for the purpose of the fence diagrams. Thus, the transects can be thought of as 'best-fit- lines. The expected result of the averaged thicknesses for the three fence diagrams was as follows: the northern and southern banks should have a slightly less thick horizon of debris flood material, due to the gradient of the lagoon. The debris flood material should have flowed and deposited more sediment in the direction of least resistance, which was via the deepest part of the lagoon rather than the edges.

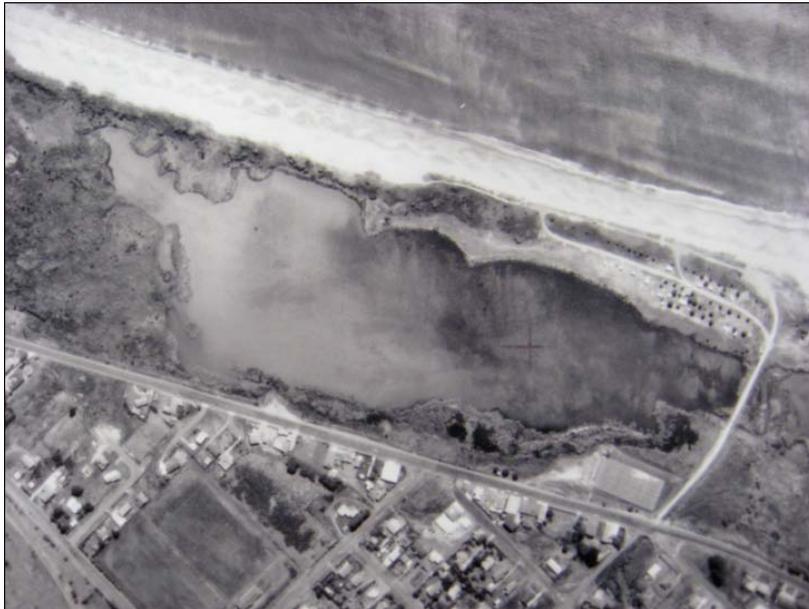
Figure 7: Aerial Photo of Te Awa o Te Atua, 1987. Photo courtesy of NZ Aerial Mapping Ltd.

point, a stereograph constructed a 3-dimensional image of Te Awa o Te Atua (See Figure 7). This image provided a realistic visualization of the depth and location of the lagoon prior to 2005, which would have affected the deposition localities and thicknesses from the debris flow event.
