Sedimentation Within the Woolston Cut And Its' Associated Flood Risks

Francisco Perez Jr.

*University of Canterbury, Christchurch, New Zealand, Department of Geological Sciences
Skidmore College, Saratoga Springs, NY, Department of Geological Sciences*

11 June 2012

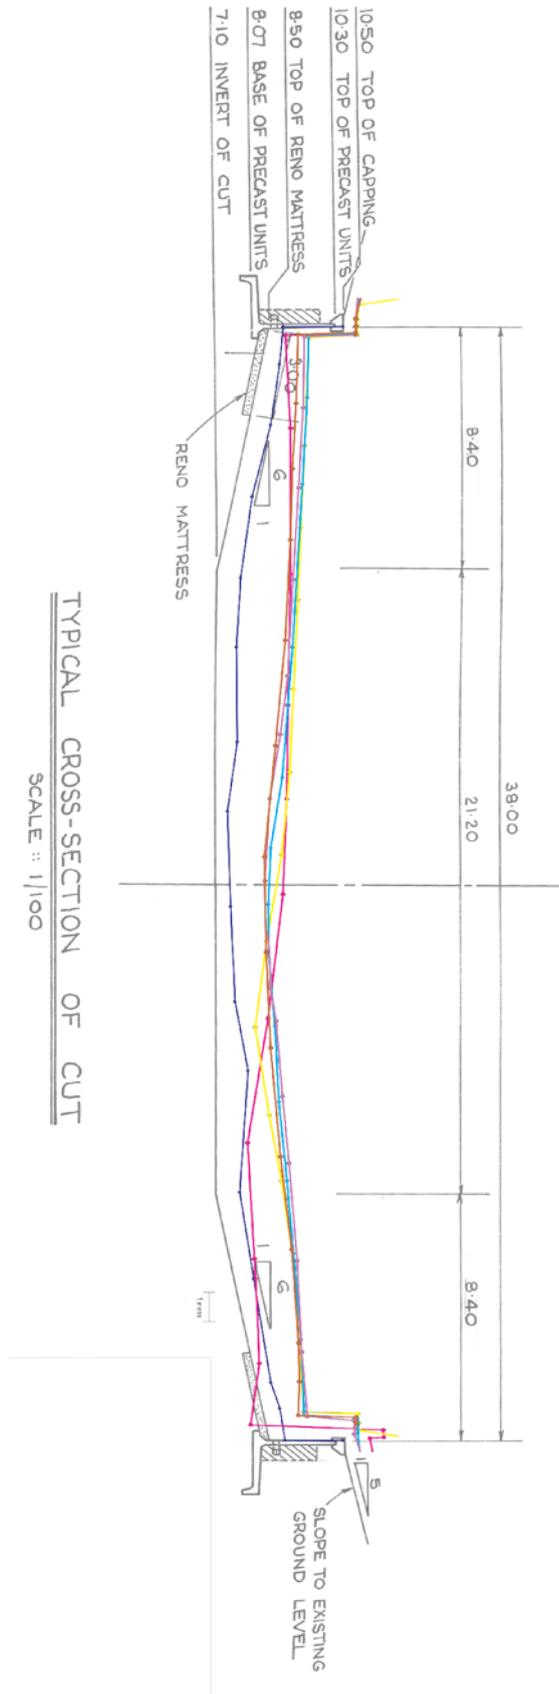
Figure 1. CCC Survey Data Overlain on Original Woolston Cut Cross Section Schematic

After overlaying the CCC survey data onto the original design of the Woolston Cut in Corel Draw, an interesting observation was made. The canal itself on the right side had moved inwards about 1 meter and upward 0.3-0.5m. The left side of the canal moved inwards approximately 0.3m and upwards 0.3-0.5m as well (See Figure 1).

The Woolston Cut itself has actually moved upwards and inwards due to lateral spreading caused by the earthquakes. This is evident not only through the infield survey we did but by the CCC data that was overlain on the original design schematic. This is interesting because the movement of the cut means that it has an increased elevation and lessened storage capacity. This factor accompanied with liquefaction and subsidence of the surrounding area means that there is a much higher potential for flood risk.

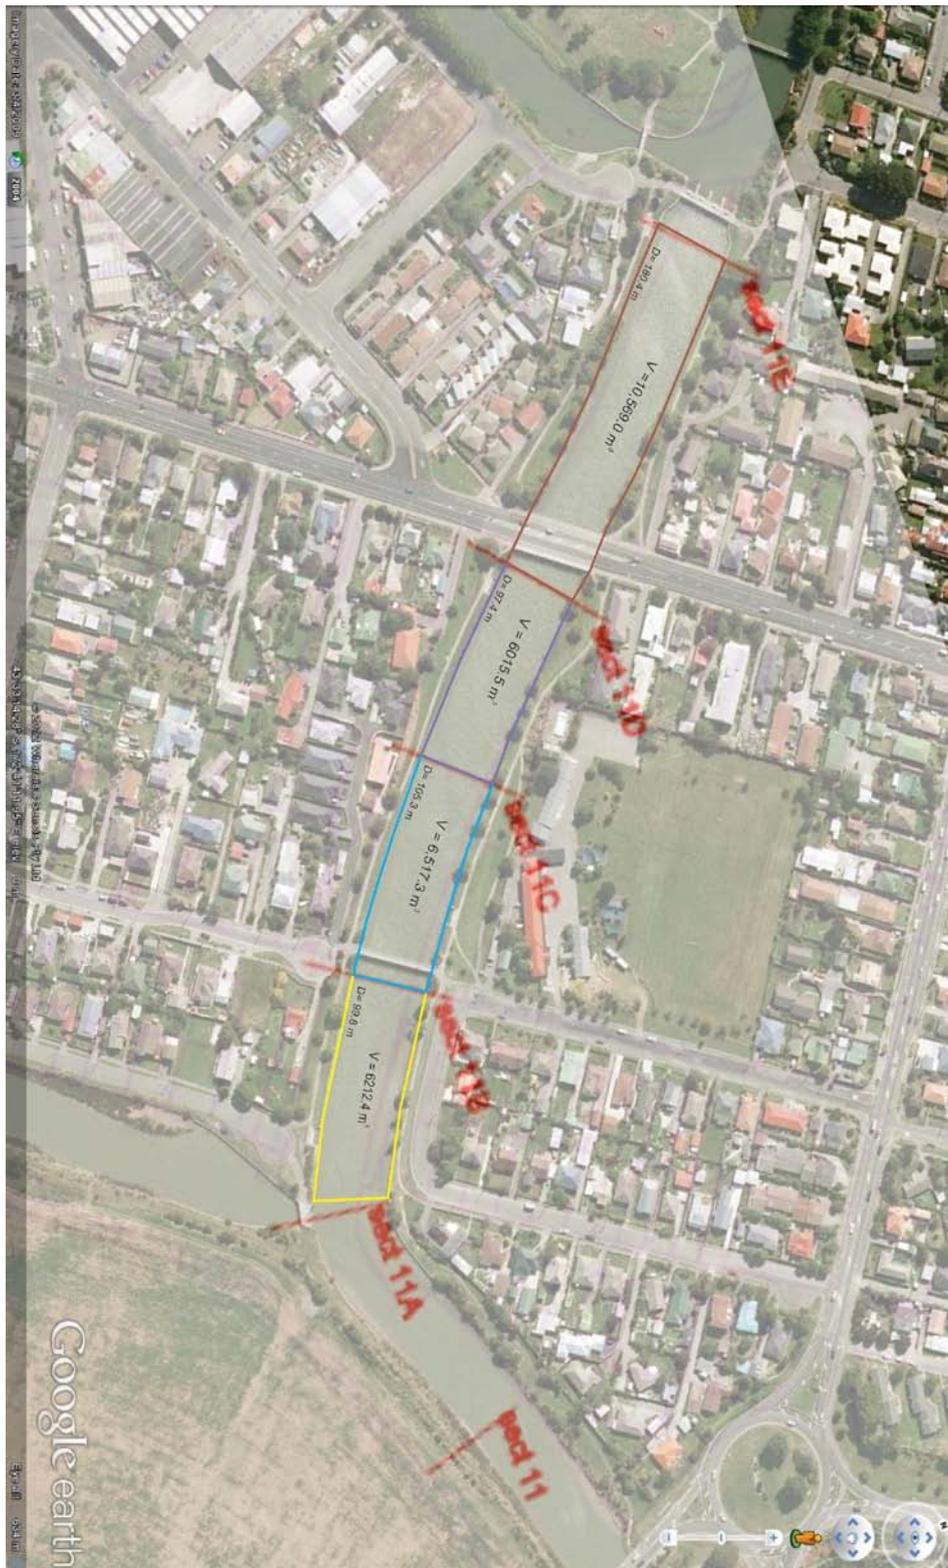
Figure 2. 2011 Cross Sectional Volumes of Sediment

Through the use of the data received from the CCC, sediment volumes were calculated for each cross sectional area. The lower reaches of the Woolston Cut have less sediment accumulation than that of the upper regions. The 2011 cross sectional volumes of sediment can be seen in Figure 2.

The original storage capacity of the Woolston Cut was ~62,394.56 m³. However, the total volume of sediment throughout the cut in 2011 was approximately 29,212.5 m³. This number is striking in comparison to the estimated sediment volume from 1990 which was ~ 10,074.0 m³. So, in 21 years there has

been an increase of 19,138.6 cubic meters of sediment within the Woolston Cut. This also means that nearly 47% of the cut has been infilled with sediment.

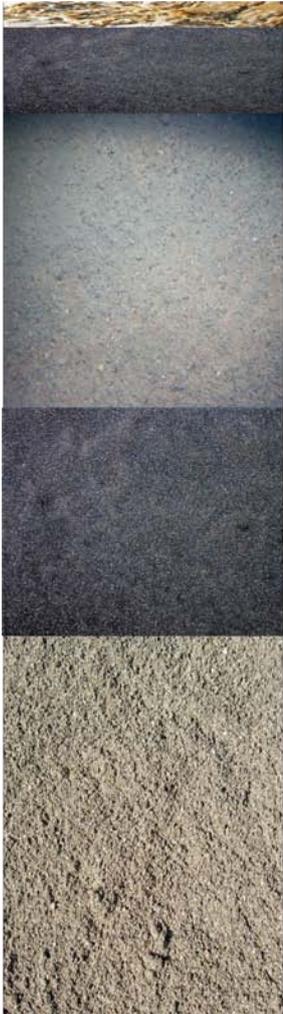
Figure 3. *Stratigraphic Log of Sediment within Test Pit*

stratigraphic log of the sediment from the test pit was created (See Figure 3).

D: 73-80 cm horizon: Black, shiny, very well sorted silt with yellow-brown excrement.

C: 40-73 cm: Grey-black, very fine, well sorted sand full of organics.

B: 30-40 cm: Black, very well sorted silt.

A: 0-30 cm: Fine, well sorted sand, slightly coarser than the 40-73 cm horizon of sand.

The stratigraphic log of the sediment that was created from the test pit may show the events that occurred within the cut. The first layer, A (0-30 cm), shows the background sedimentation of a slightly coarse but well sorted sand, perhaps from 1986-1994. B (30-40 cm) is a more fine grained, well sorted silt which may have been deposited during the flood event in 1994. C (40-73 cm) is representative of the background sedimentation again as it is also sand sized and full of organic material. D (73-80 cm) which is fine black silt with yellow-brown excrement may have been deposited from liquefaction events that occurred within and near the river. The yellow-brown excrement was deposited by the temporary sewage lines that were placed within the cut after the earthquakes occurred.

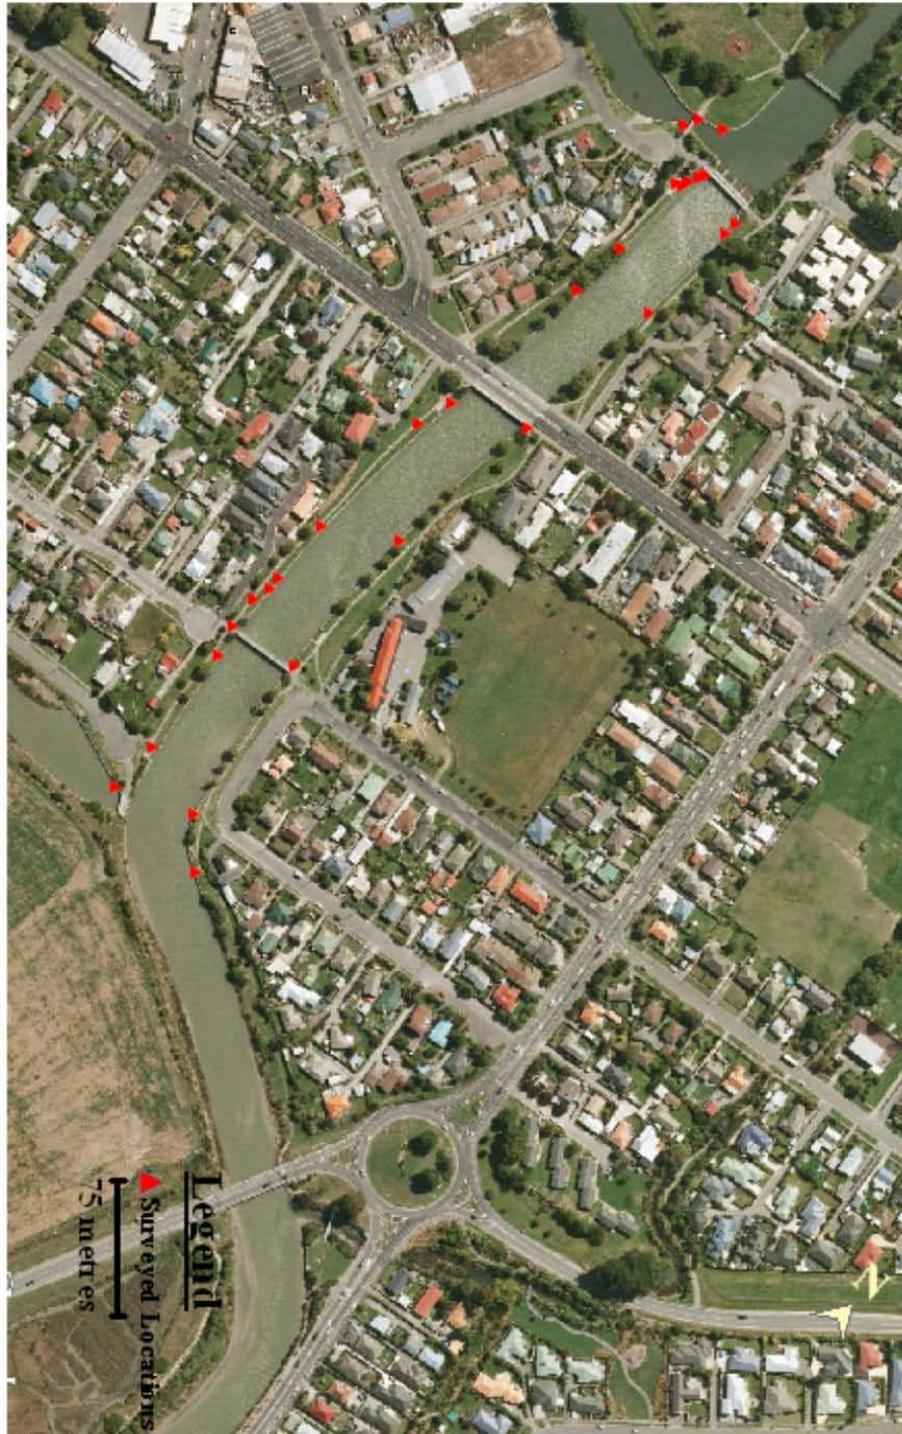
Figure 4. *Surveyed Locations at the Woolston Cut*

Damage within the research site was surveyed to determine how lateral spreading affected the Woolston Cut and adjacent area; photos were also captured to record the damage. Figures 4 and 5 show areas where measurements were
240 taken and the damage digitally captured.

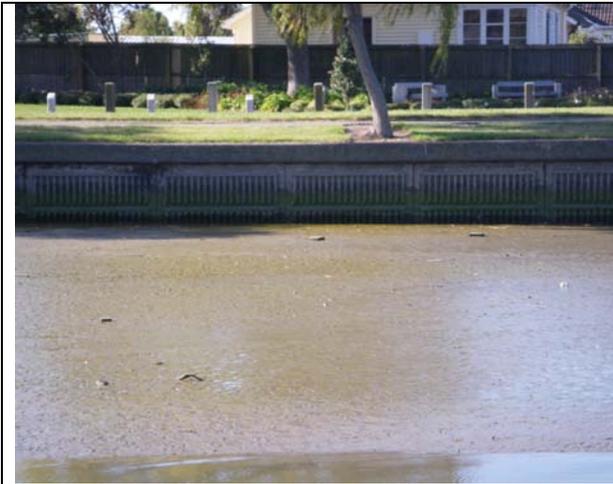
Figure 5. *Damage in the Cut at Several Locations*

Sediment and excrement within the Woolston Cut.

However, the easily erodible loess soils, lack of vegetation, and liquefaction are not the only contributors to sediment deposition in the Woolston Cut. After the February earthquake, sewage pipes in areas surrounding the Heathcote River were damaged so temporary lines were placed in the Woolston Cut. This caused raw sewage to accumulate in the Cut which is easily visible. The wastewater is a significant contributor of the

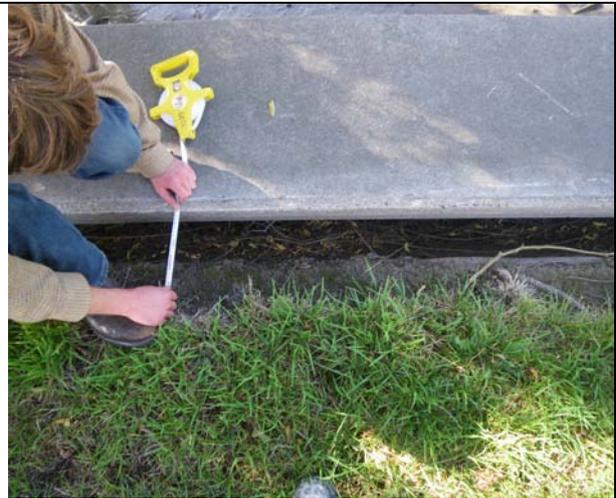
Lateral Spreading Caused the Cut to Move Inwards and Away from the land.

the canal and bank by an average of 9.4 cm and the canal itself had uplifted in some parts by an average of 6 cm. There was more uplift and apparent lateral spreading on the western side of the canal facing NW.

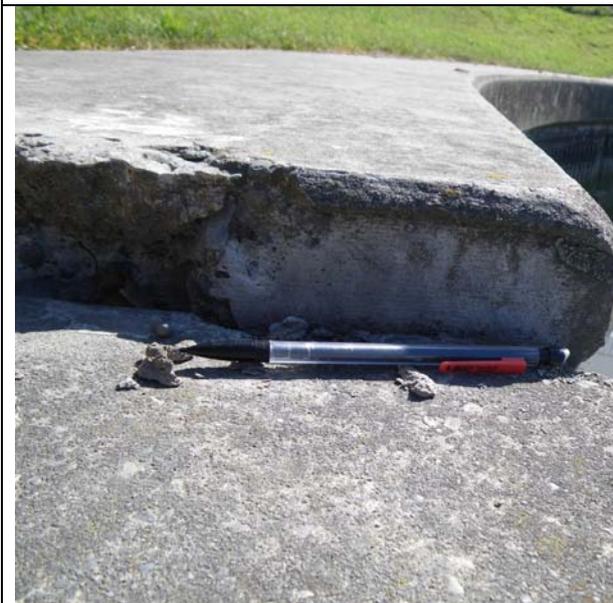
Uplift of the Cut

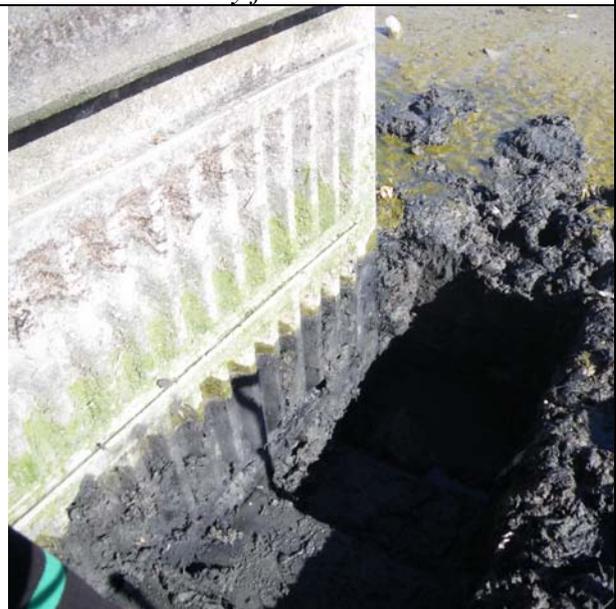
Test Pit that was dug 80cm down.

The original designs were viewed and it was determined that there were 10 steps that led to the base of the structure which assisted in analyzing the depth of sediment within the cut across several channel sections. It was determined that exactly 4 steps and the base of the cut were covered by sediment. In the test pit that was dug, there was a vertical accumulation of about 80 cm of sediment. Nearly half of the canal was vertically filled with sediment as the length from the base to the bottom part of the precast unit (Fig. 3) measured 175 cm (this correlates with the filled capacity percentage which was 47%).
