Water Quality of the Tarawera River:
A Pollutant Input Analysis of the Tasman Pulp and Paper Mill

Kawerau, New Zealand
Autumn 2010

Jamie Shannon
Frontiers Abroad Earth Systems Program
University of Auckland, New Zealand

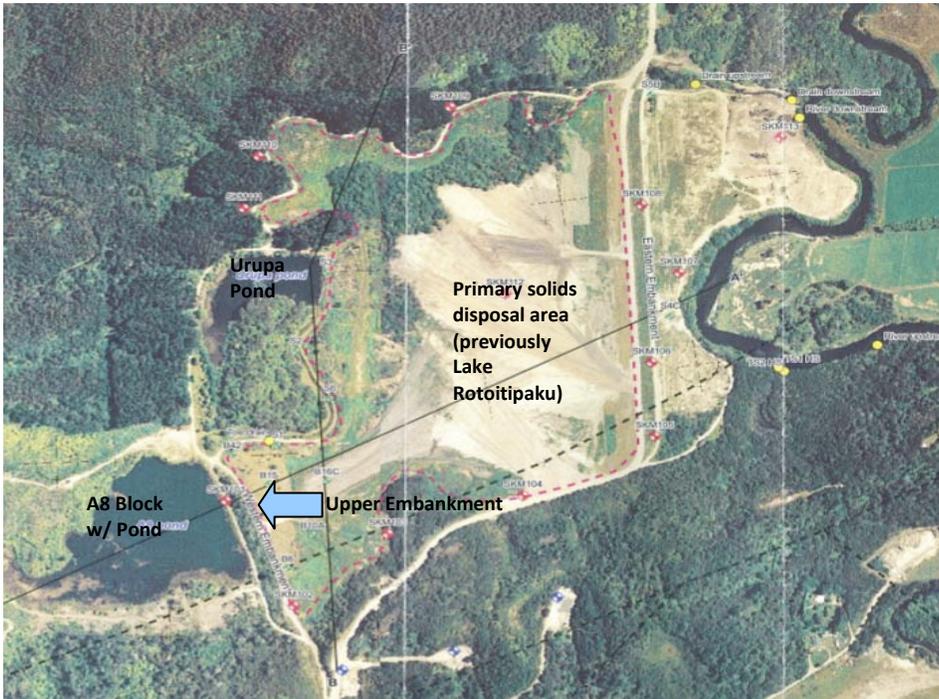
Figure 2. Mill Waste Disposal Site. Previously the site of Lake Rotoitipaku, this aerial photograph shows the current status of the waste disposal site.

The mill itself sits only 300 meters from the Tarawera River. When the mill was first established, the untreated waste was dumped directly into the river. In 1964, the mill gained access to land owned by a local Maori trust (A8 land-block, see Figure 2) to be used as a waste disposal site through the Tasman Pulp and Paper Enabling Act (Tull & Vengosh, 2008). Since then, sludge has completely inundated Lake Rotoitipaku, leaving a toxic waste site in its place (see

In 2004, Gulf Resource Management Ltd (GRML) was hired by Norske Skog Tasman to assess the risk of contamination of the A8 block, including the upper embankment and the primary solids waste disposal areas (see Figure 2).

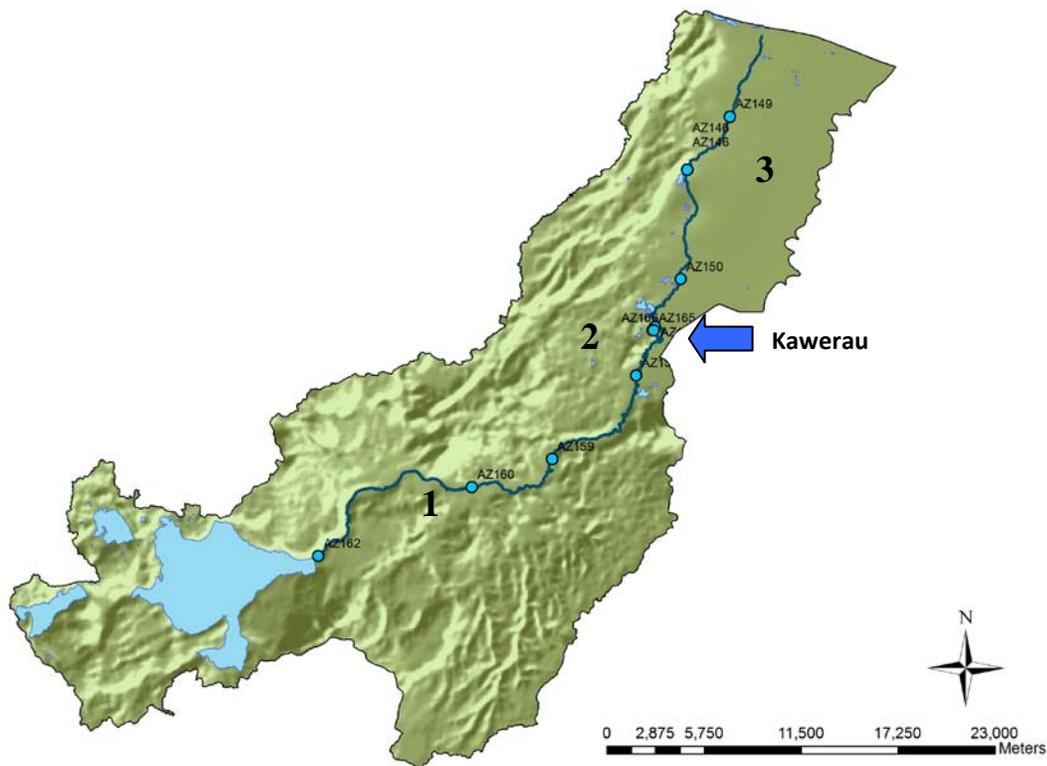
Figure 3. *Map of Water Sampling Locations.* Samples were taken from three regions: upstream of the waste site (1), on or directly adjacent to the waste site (2) and further downstream of the where the waste discharges into the river (3).

Water samples were collected from eleven sites in three regions to assess spatial variation in relation to proximity to the mill (see Figure 3). Three surface water samples were taken from location 1 (upstream of the mill) four surface water sites and two groundwater sites at location 2 (directly adjacent to the mill) and three surface water sites from location 3 (well downstream of the mill). One sample was taken straight from the discharge flow, and another was taken further downstream of where the waste water enters the river. All the samples were taken over the course of the week of February 12th, 2010.

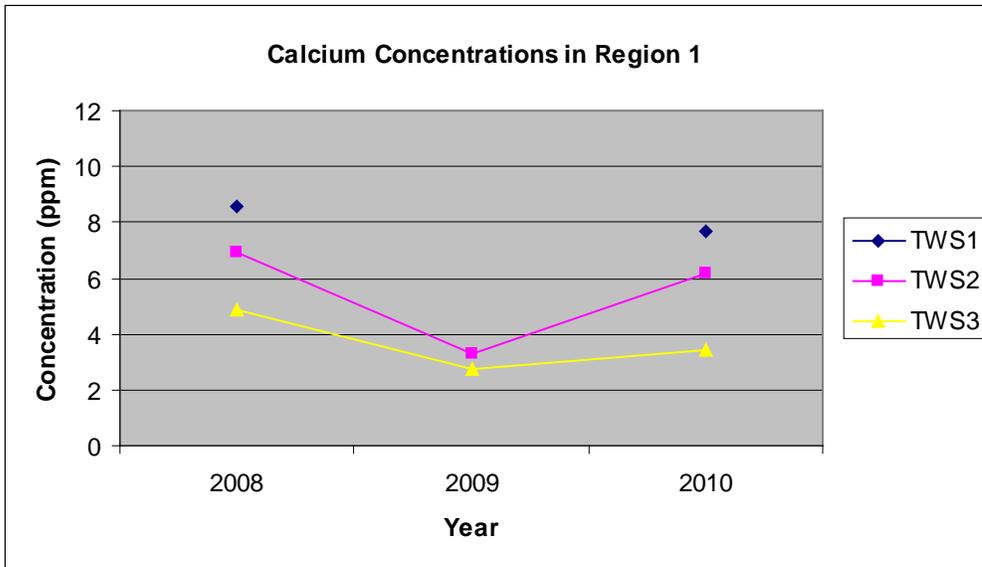
Figure 6. Calcium Concentrations from 2008-2010 in Region 1.

Calcium concentrations in region 1 ranged from 3.45-7.68 ppm. These values were all slightly higher than those obtained last year (see Figure 6). In contrast, potassium levels at the three sites in region 1 were essentially the same as they were in 2009, dropping approximately 0.2 ppm at each site (see Figure 7). Sodium levels decreased significantly, from 52 ppm to 10 ppm at TWS2 and 48 ppm to 14 ppm at TWS3 (see Figure 8).

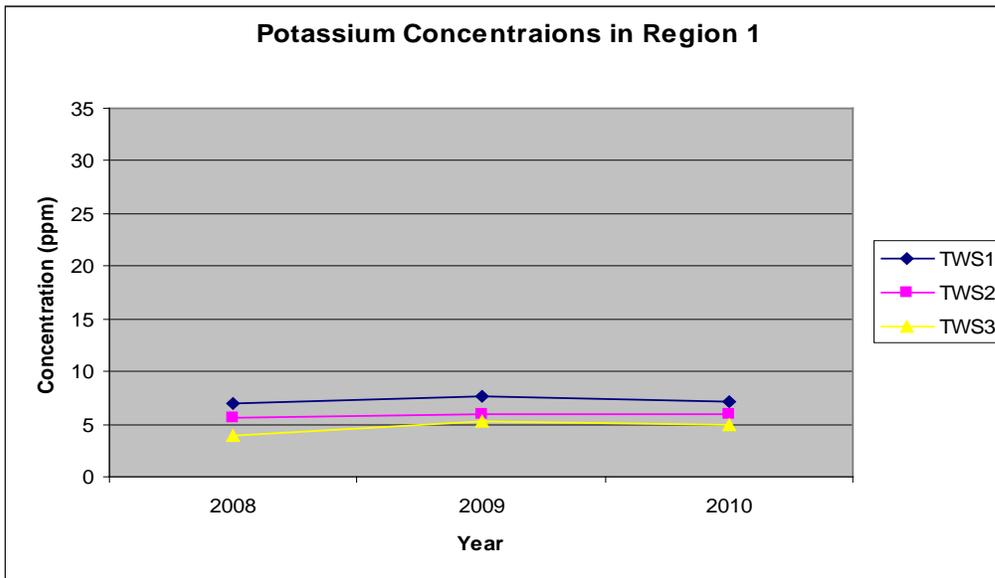
Figure 7. Potassium Concentrations from 2008-2010 in Region 1.

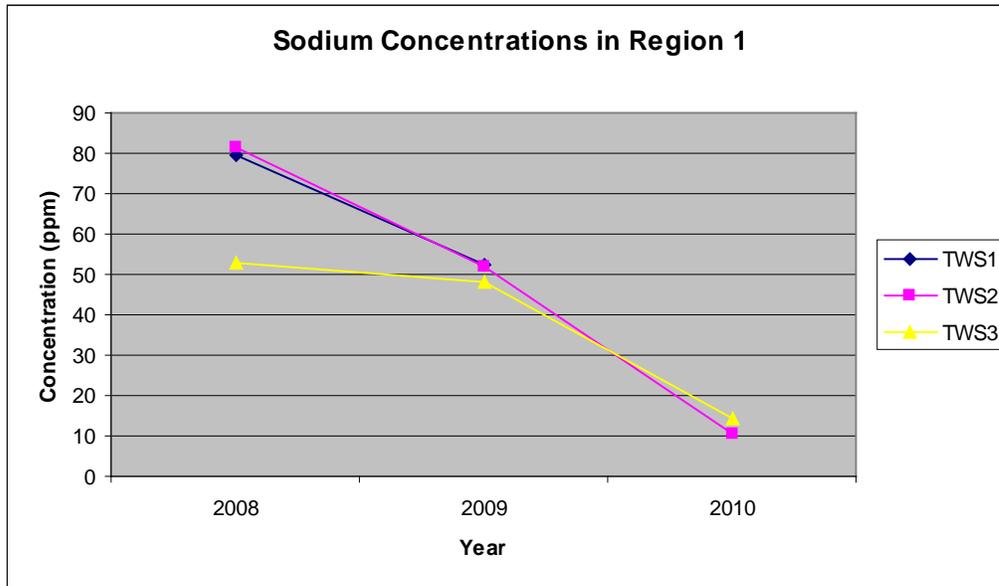
Figure 8. Sodium Concentrations from 2008-2010 in Region 1.

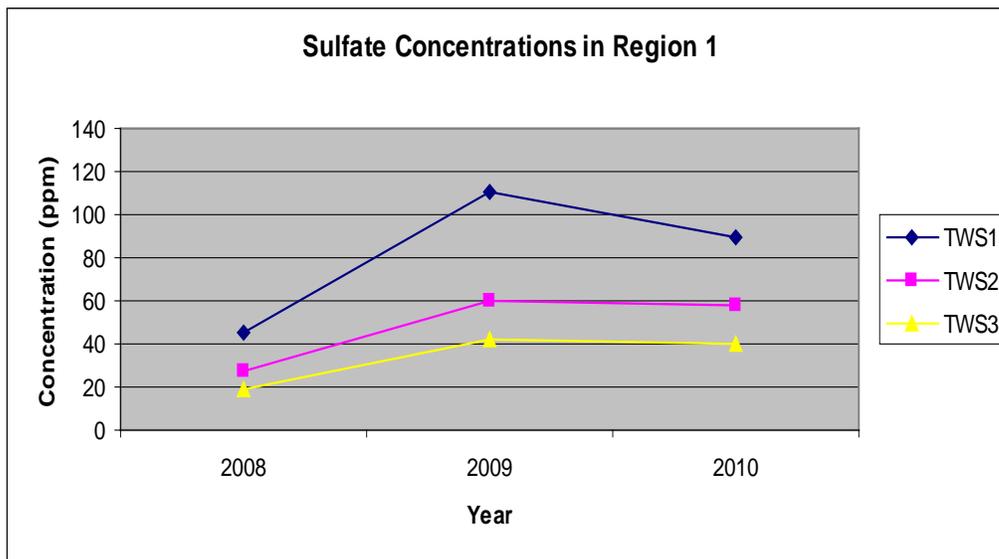
Figure 9. Sulfate Concentrations from 2008-2010 in Region 1.

The concentration of the two anions, chlorine and sulfate, decreased in every case with the exception of chlorine at TWS3. Here the chlorine concentration increased from 98 ppm to 109 ppm. All other values dropped slightly. Chlorine concentrations for 2010 ranged from 109-135 ppm while sulfur levels varied between 40 ppm and 90 ppm (see Figures 9 & 10).

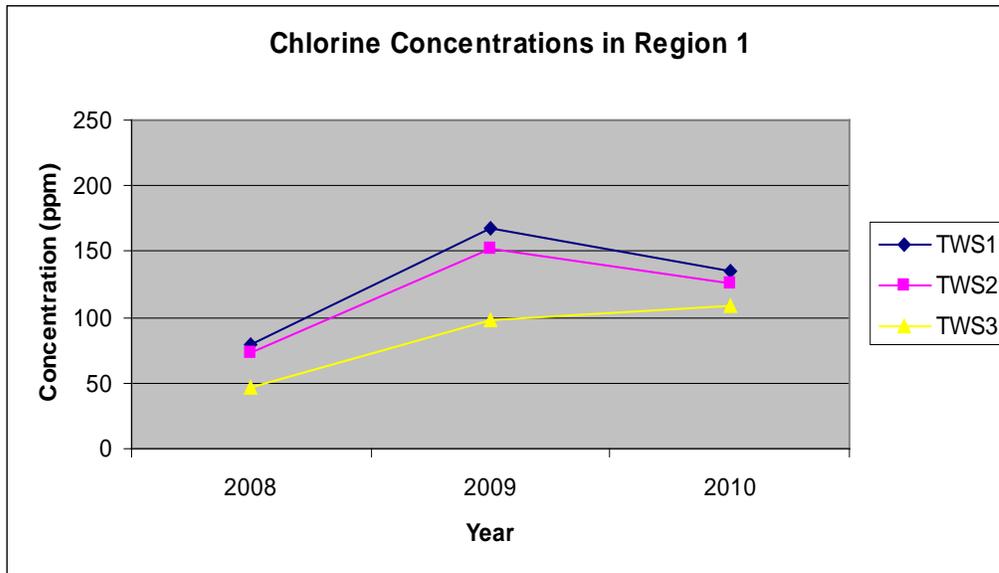
Figure 10. Chlorine Concentrations from 2008-2010 in Region 1.

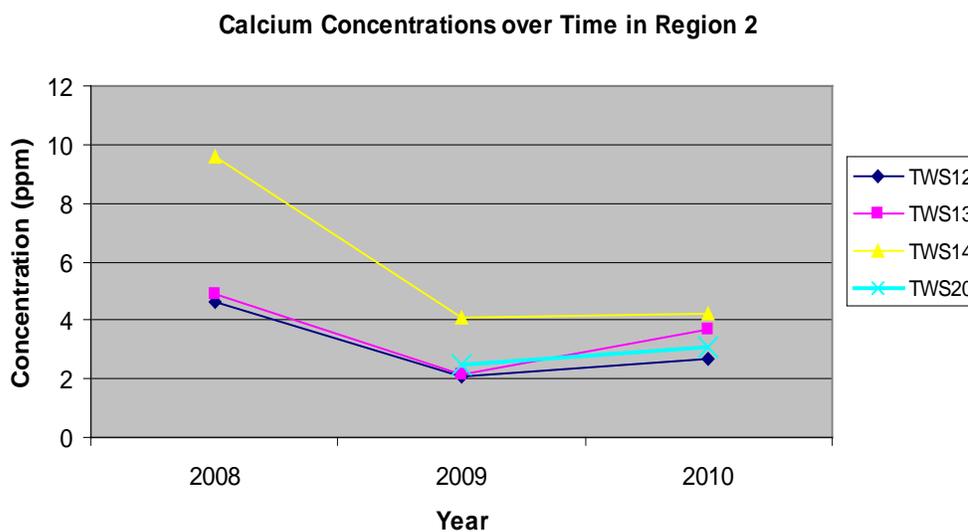
Figure 11. Calcium concentrations from 2008-2010 in Region 2.

After dropping by nearly 50% each between 2008 and 2009, calcium concentrations all increased slightly from 2009 and 2010 and were in the range of 2.66 ppm to 4.233 ppm (see Figure 11). It is interesting to note that these values still remained on average lower than the calcium concentrations of region 1. Potassium concentrations increased very slightly at TWS 12 & 13, while decreasing by 2 ppm at TWS 14 (see Figure 12). Sodium levels were significantly lower than previous years, with the exception of TWS 14, a geothermal spring, which still registered as too high for instrumental analysis (see Figure 13).

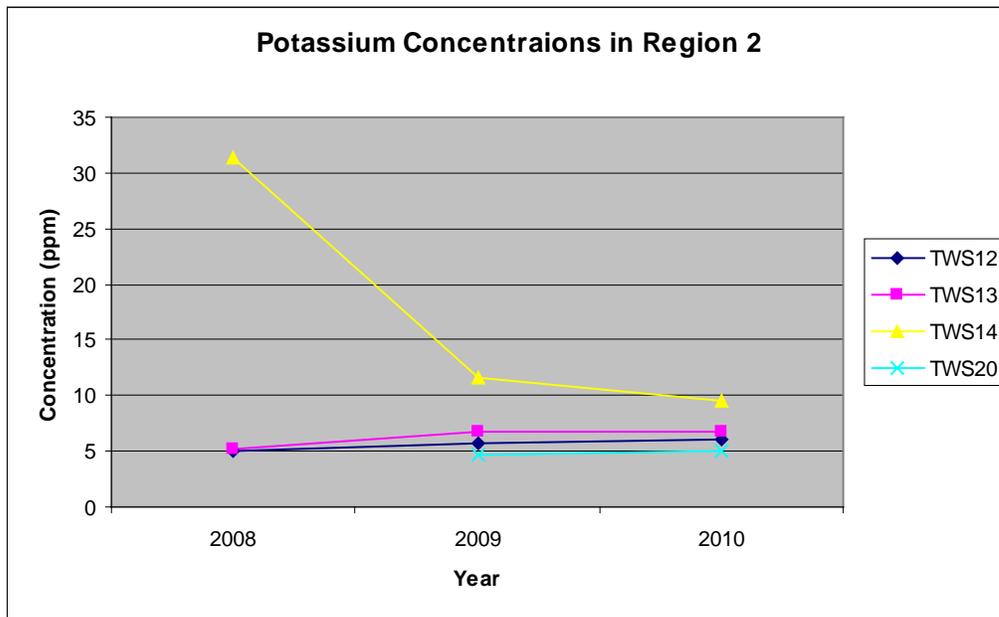
Figure 12. Potassium concentrations from 2008-2010 in Region 2.

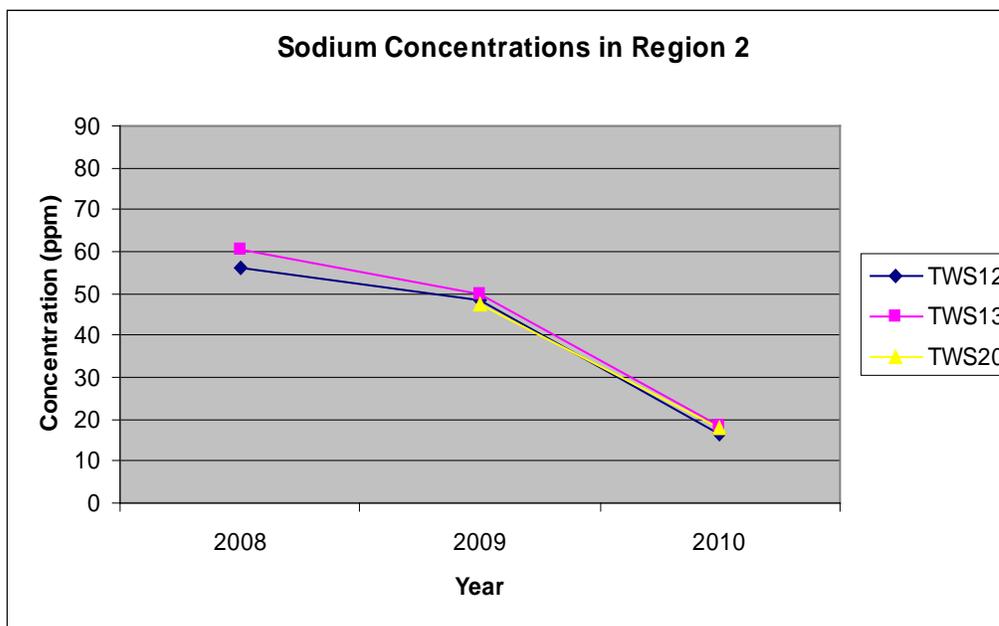
Figure 13. Sodium Concentrations from 2008-2010 in Region 2.

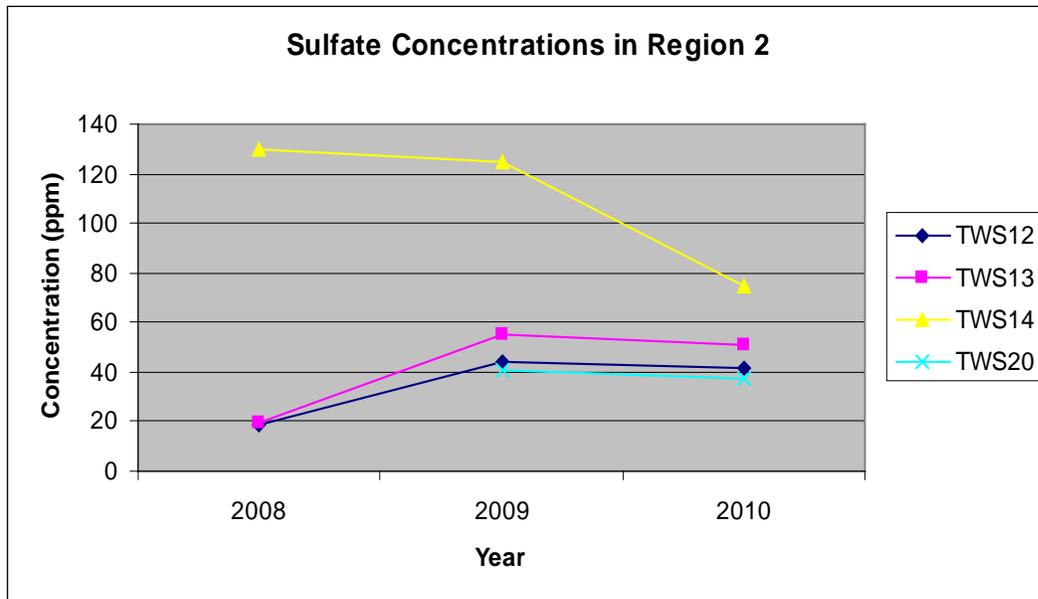
Figure 14. Sulfate Concentrations from 2008-2010 in Region 2.

All sulfate measurements decreased slightly from last year's data. TWS 14 experienced the greatest drop, from 124 ppm to 74 ppm (see Figure 14). Chlorine levels at TWS 12 and TWS 13 both decreased by about 20 ppm, while TWS 14 again shows a larger reduction from 209 ppm to 136 ppm (see Figure 15).

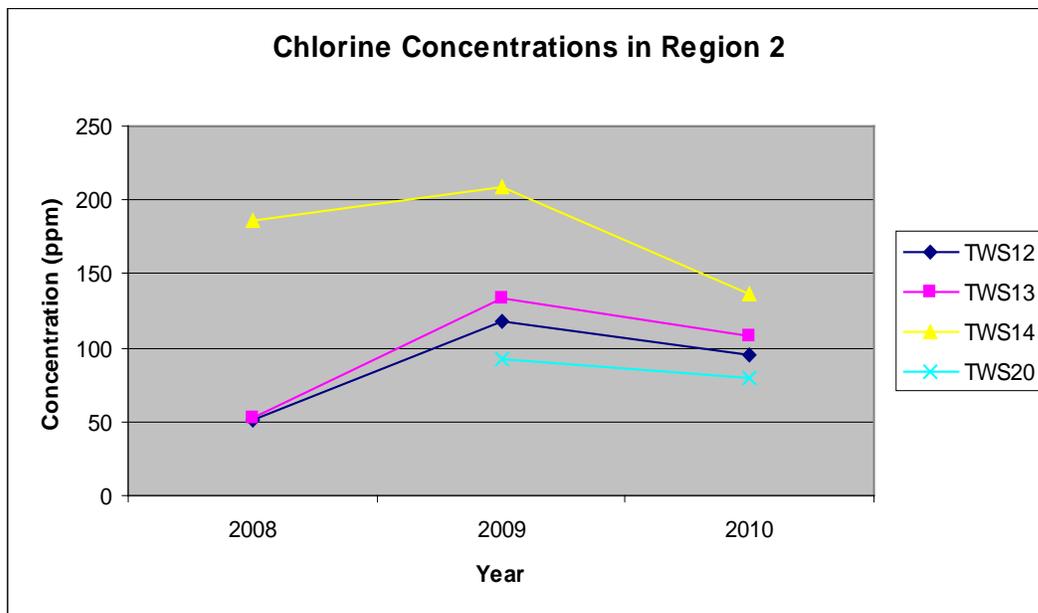
Figure 15. Chlorine Concentrations from 2008-2010 in Region 2.

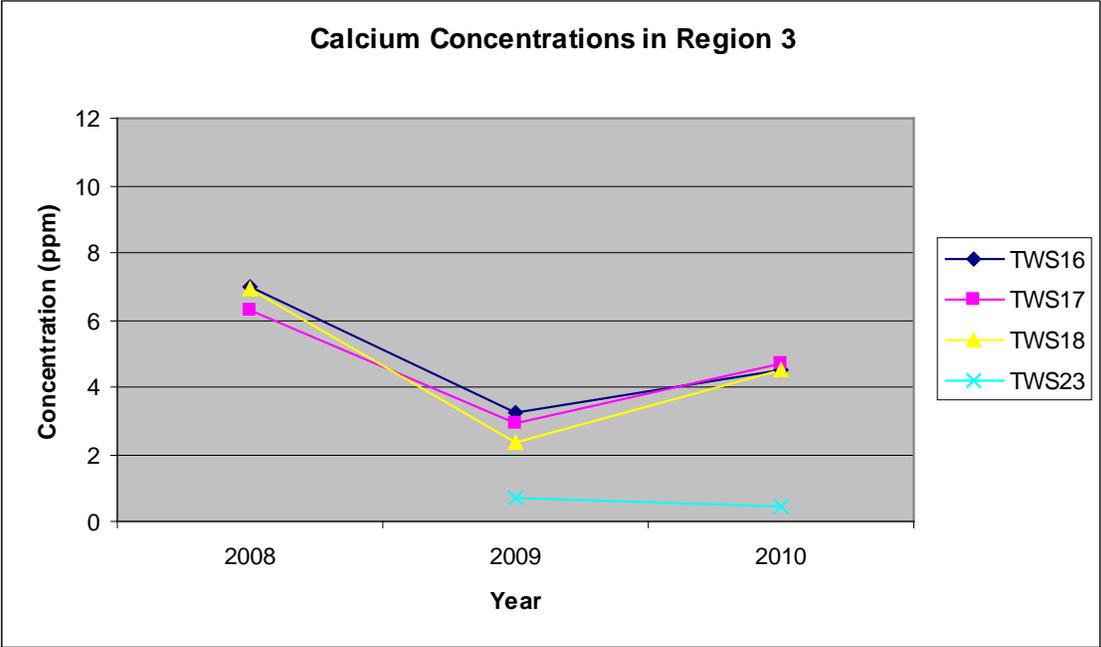
Figure 16. Calcium Concentrations from 2008-2010 in Region 3.

Calcium levels decreased by over 50% between 2008 and 2009, but experienced a slight increase between 2009 and 2010 (see Figure 16). The only exception to this was TWS 23, Braemar Spring, which barely registered in 2009 or 2010 (no data exists from 2008). Concentrations of potassium in region 3 samples all dropped slightly (see Figure 17). Like regions 1 & 2, the most

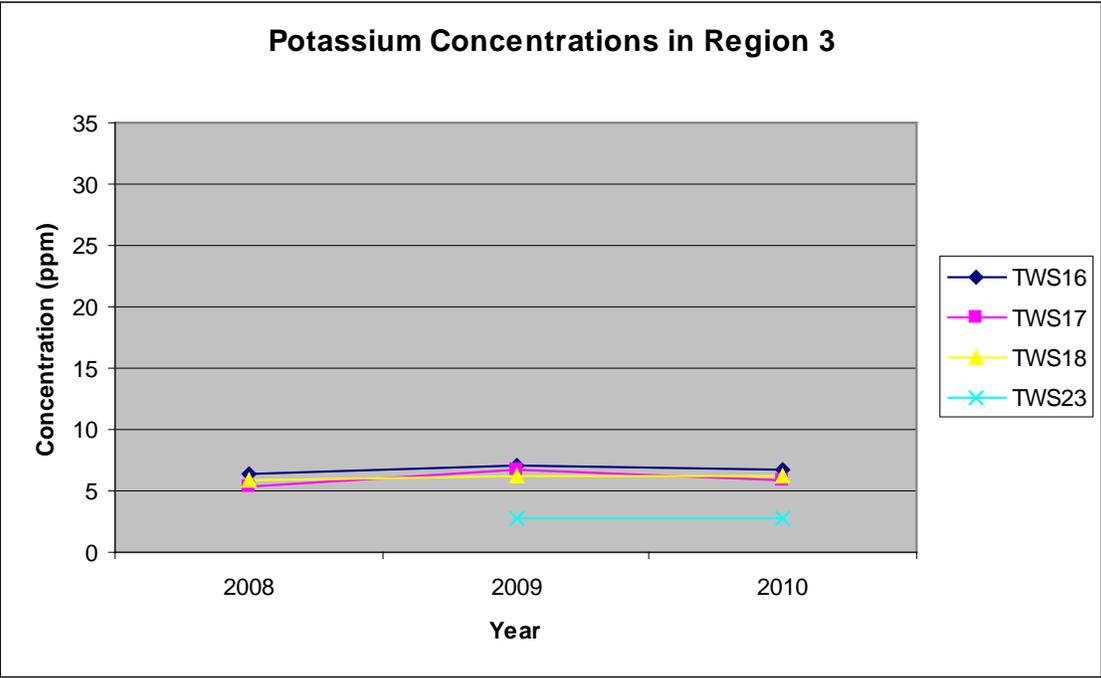
Figure 17. Potassium Concentrations from 2008-2010 in Region 3.

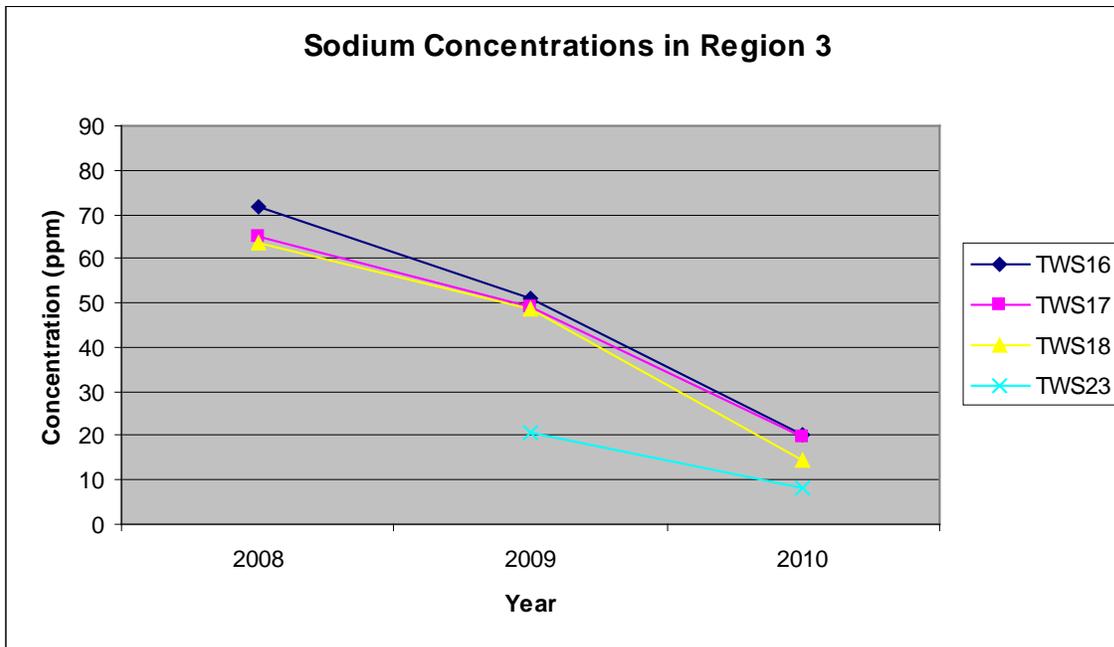
Figure 18. Sodium Concentrations from 2008-2010 in Region 3.

significant temporal variation was in sodium concentrations, which decreased from around 50 ppm to between 14-20 ppm in all samples (see Figure 18).

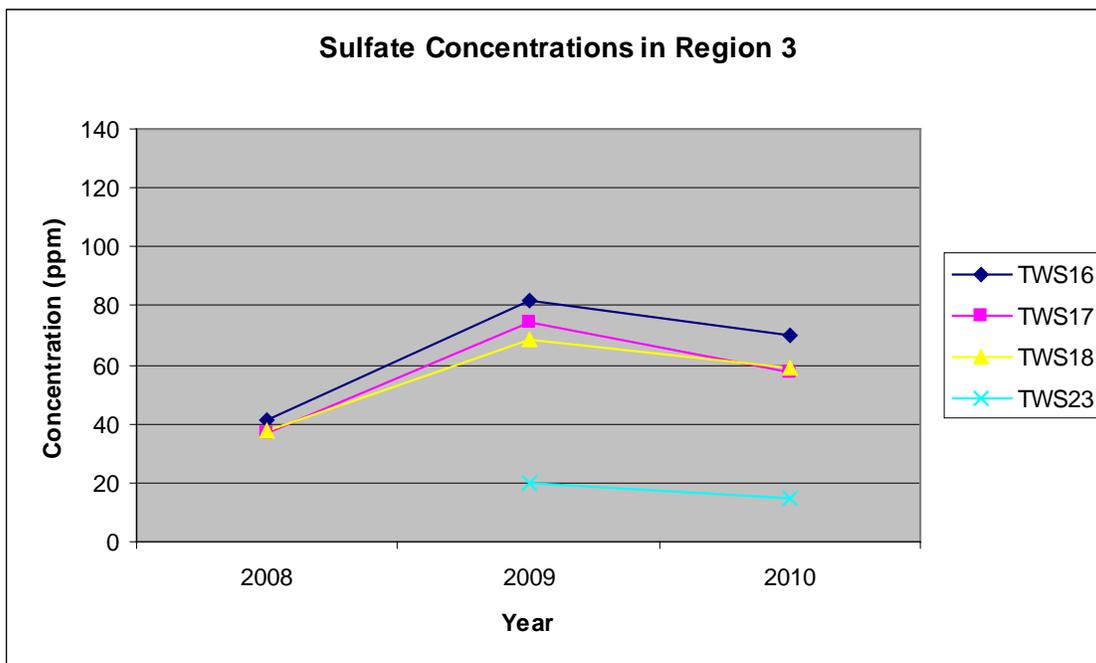
Figure 19. Sulfate Concentrations from 2008-2010 in Region 3.

Similar to regions 1 & 2, concentrations of sulfate and chlorine decreased in region 3 samples between 2009 and 2010. Sulfate values were slightly higher than those found in region 2, ranging from 57-70 ppm (see Figure 19). Chlorine levels, on the other hand, were comparable to region 2 and slightly below region 1 values (see Figure 20).

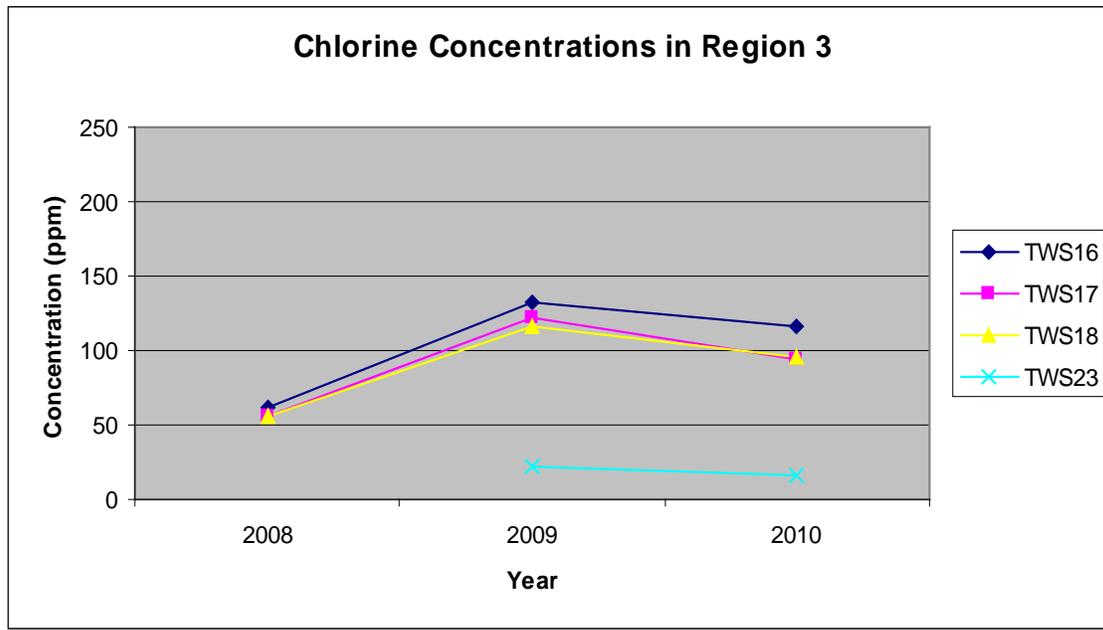
Figure 20. Chlorine Concentrations from 2008-2010 in Region 3.

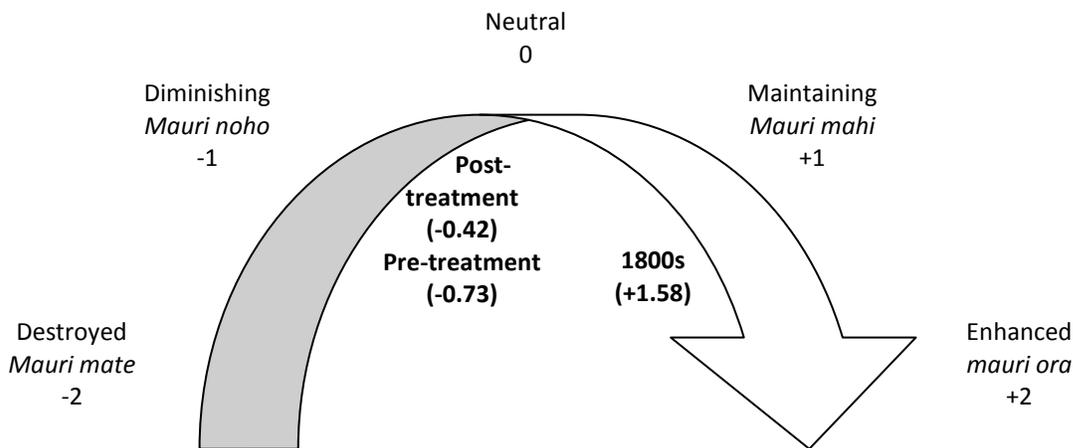
Figure 22. *Sustainability Barometer for Mauri* (adapted from Morgan, 2006). This diagram shows where the three ratings of the Tarawera River mauri fall on the mauri scale.

Each of the four dimensions is measured with three ratings (see Figure 21). Each rating is given an integer score between -2 (mauri destroyed) and +2 (mauri enhanced - see Figure 22). A Mauri Model assessment of the mauri of the Tarawera River was undertaken as part of this project, the results of which are presented below. Prior to development, the mauri of the Tarawera River was +1.58, classified as between “maintaining” and “enhanced” mauri. This is representative of a healthy system. After construction of the mill, before a waste treatment system was implemented, the mauri of the system decreased drastically to -0.73, or “diminished” mauri. Scores decreased in every dimension except for economic where the boost in the local economy, employment and property value were all rated positively. The mauri improved slightly with the addition of a waste treatment plant, although the overall mauri score is still below zero, indicating degradation of the well-being over time.
