# Heavy Metal Absorption in Okahu Bay Sediment

Eleanor Beckwith

**University of Auckland School of the Environment**

6/21/2013

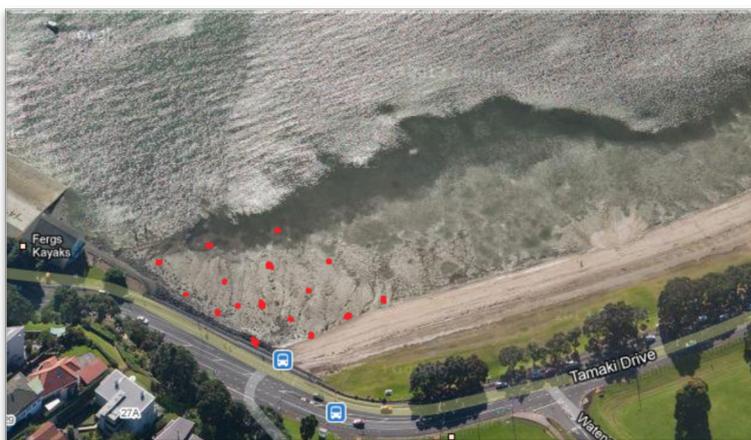
Figure 4 Southeast Corner of Okahu Bay and rough schematic of collection points. Google maps.

Samples were collected February 22, 2013 in the Eastern corner of Okahu Bay (Fig. 3) at low tide. The samples were collected over three hours. No rain had occurred in the area over one week prior to collection, but a small amount of clear water was flowing out of the drainage

pipe consistently. The top 0-3 cm of sediment was collected in a 5-8cm diameter circle using a hand spade. Contents were placed in plastic bags, sealed, labelled, and their location recorded using GPS. Certain areas, such as sample location 13, had very little sediment on top of the bedrock (0-1 cm). One 30-meter transect extended perpendicular to the drainage pipe, and three 20-meter transects stemmed from the first transect every 10 meters (Fig. 2). Sixteen samples were collected at 10-meter intervals along transects.
